# Hotel del Coronado Front Entry and Porch Restoration Final Report to the City of Coronado

By P. David Marshall, AIA, Preservation Architect  
September 27, 2021

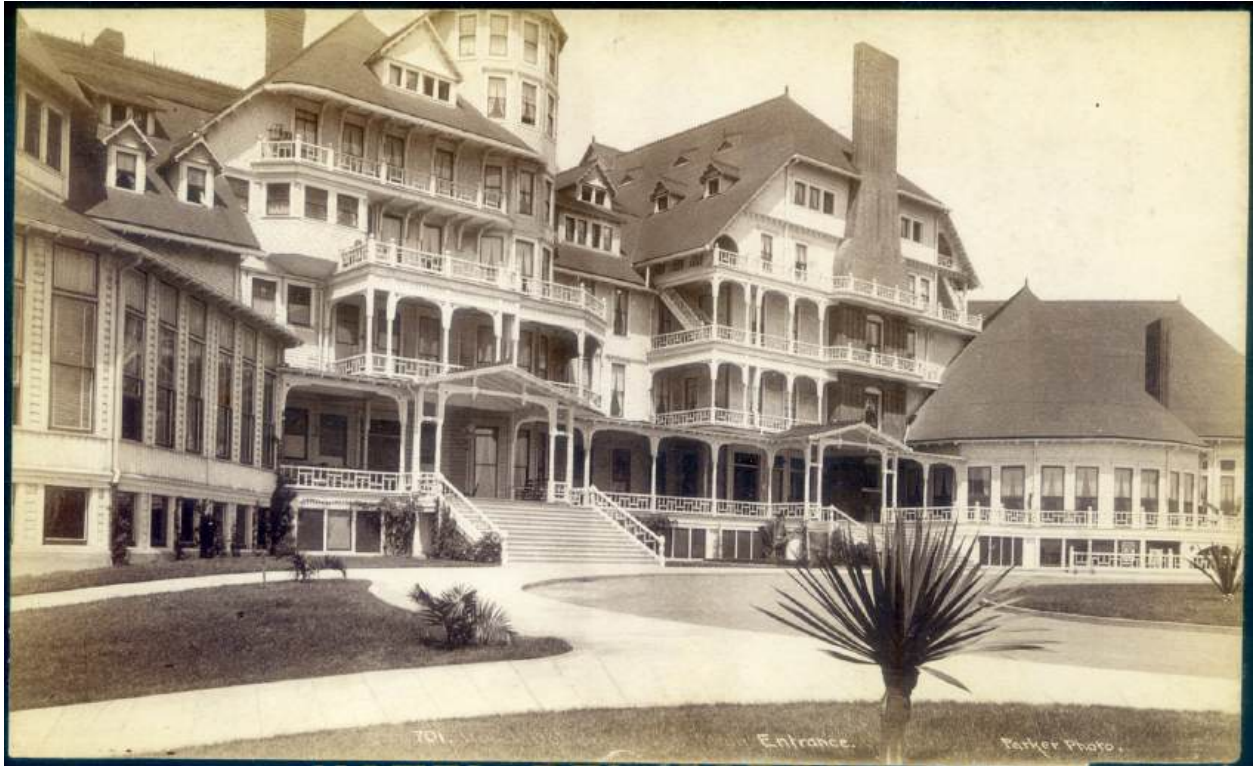
Figure 1: Historic photo showing the south façade and entry Veranda shortly after The Del was completed, ca.1890. Note the grand chimney on the right. Image credit: Bruce Coons.

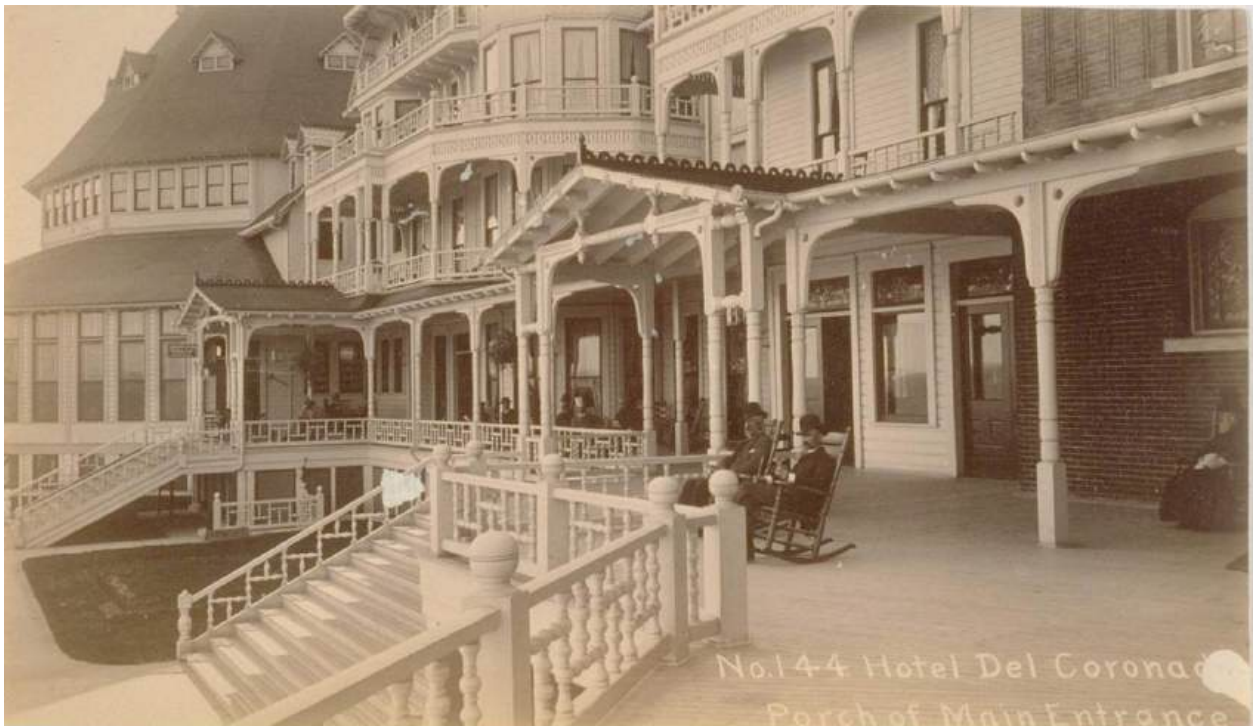
Figure 2: Historic photo of the entry Veranda, ca.1890. Note the two sets of stairs and wood floor. Also note the roof ridge cresting and many stained-glass windows. Image credit: Bruce Coons.

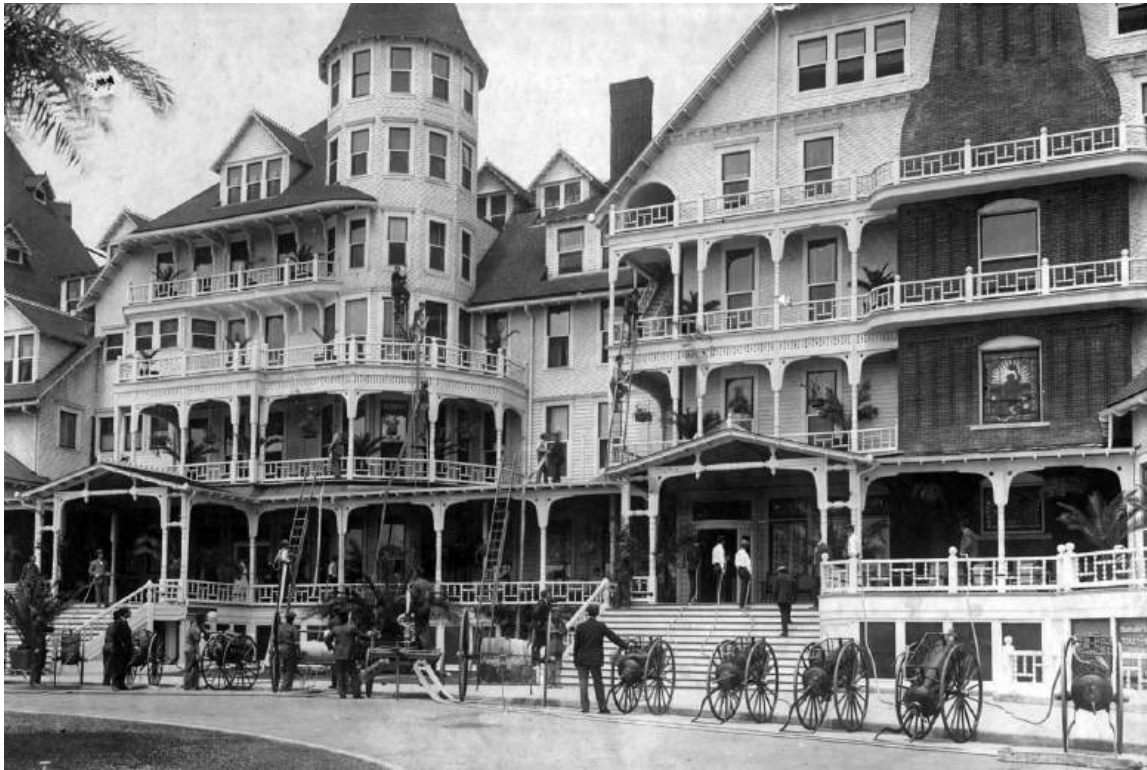
Figure 3: Historic photo of the south façade and Veranda during a fire drill, ca.1910. Note the added revolving door and picture window at the entry. Image credit: Hotel del Coronado Archives.

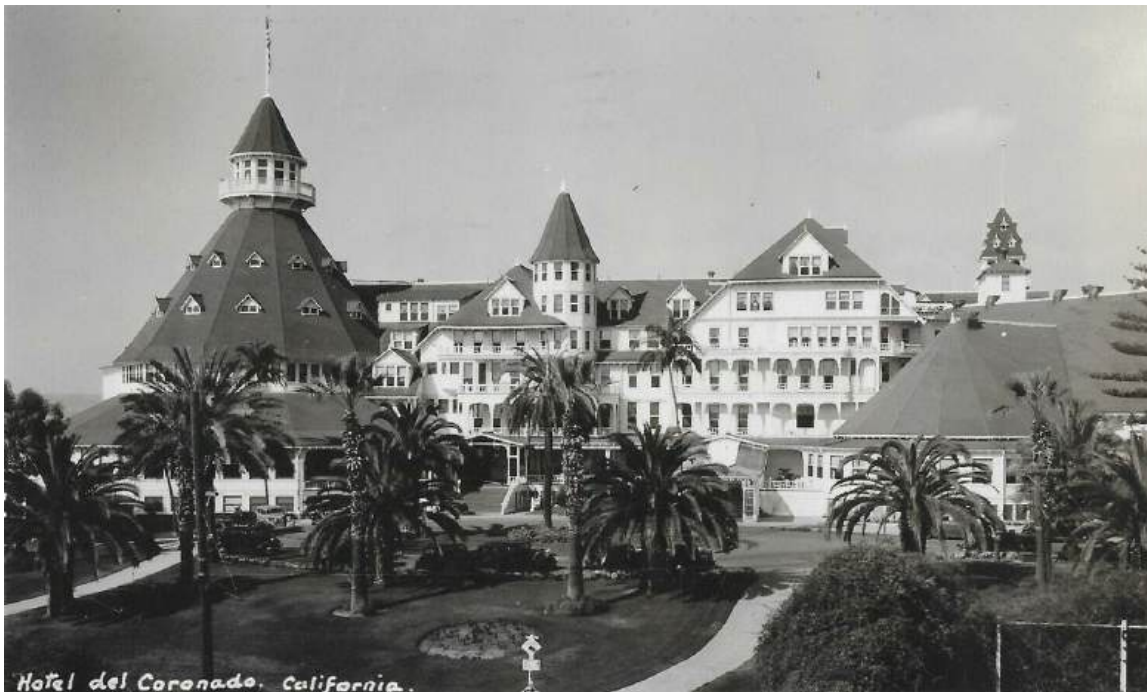
Figure 4: Historic postcard of the south façade, ca.1935. Note the missing grand chimney and added upper floor windows. Image credit: David Marshall Collection.

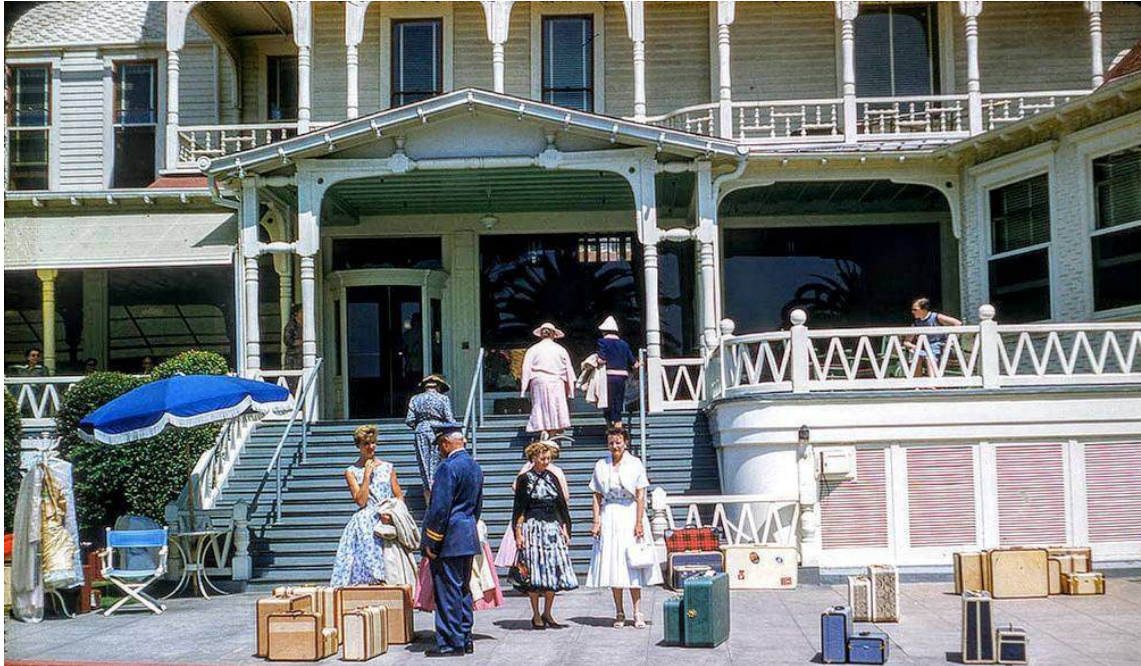
Figure 5: Photo of the entry Veranda, ca.1950. Note the altered “zig-zag” railings, additional picture windows, soffited ceiling, and extended Veranda on the left. Image credit: Hotel del Coronado Archives.

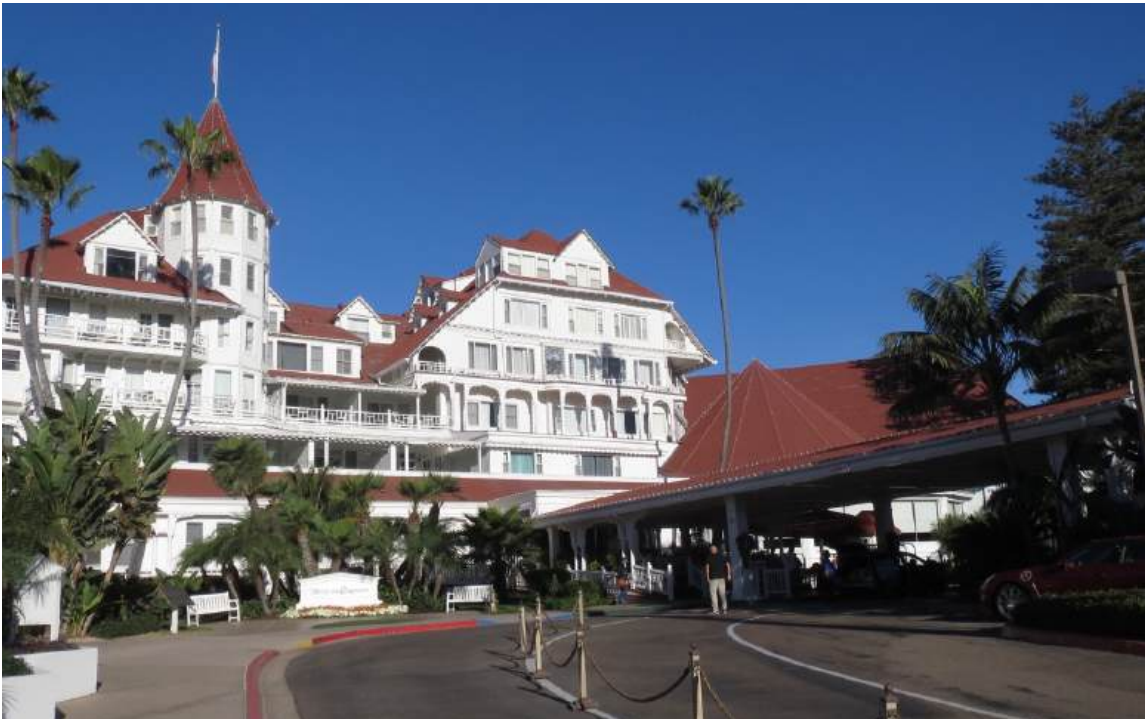
Figure 8: View of the south façade from 12-11-17 showing the infilled Veranda, missing west stairs, 1979 Porte Cochere and boxy guestroom added over the entry.

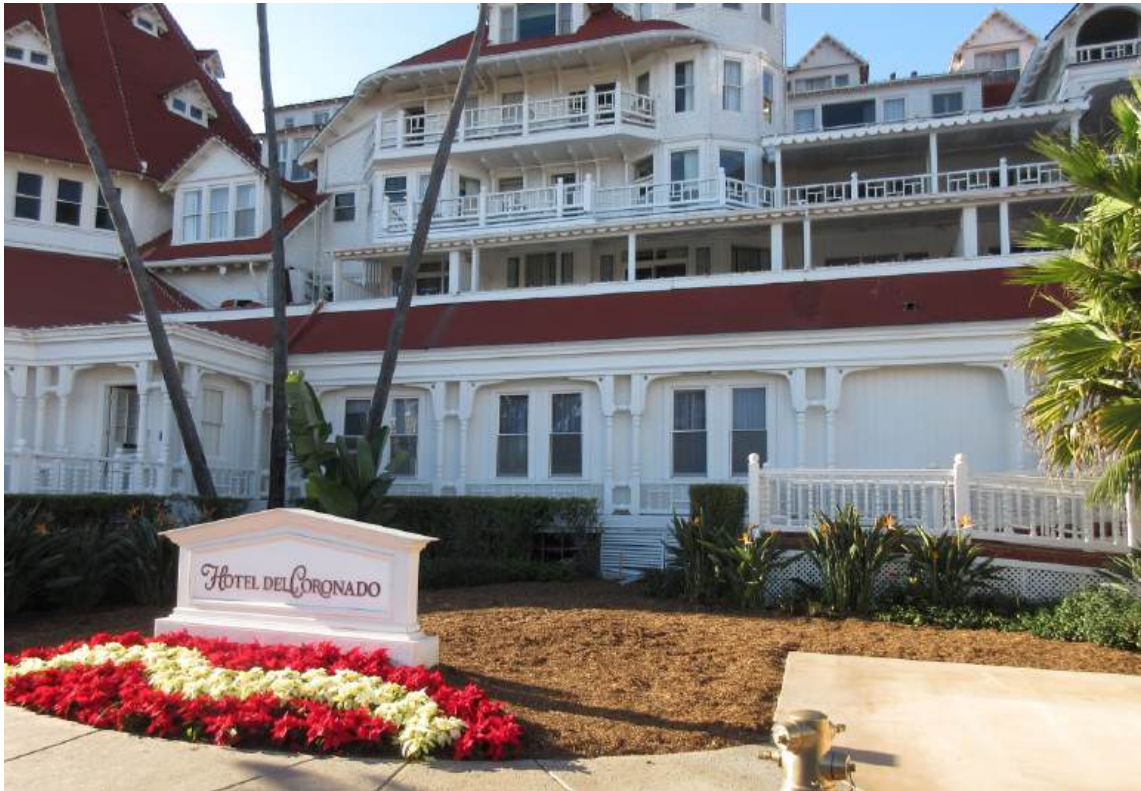
Figure 9: View of the south façade in 2018, after removal of some landscaping, showing the office walls and false Veranda columns.

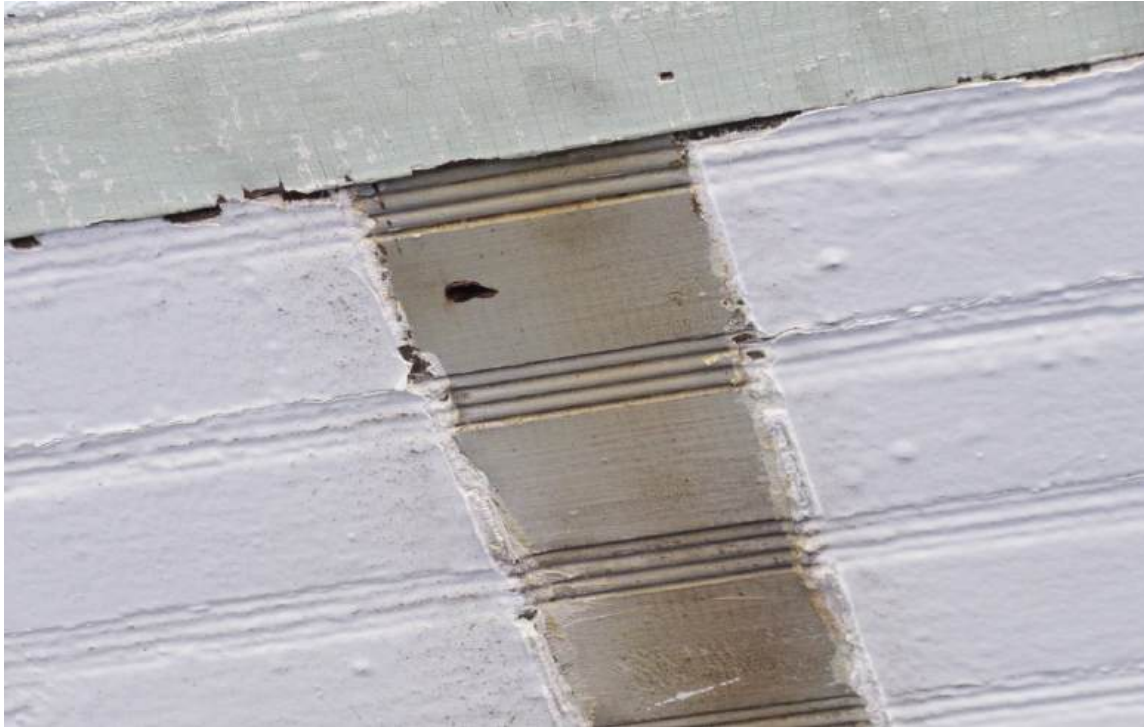
Figure 17: “Haint Blue” is exposed on a bead-board ceiling where a balcony bracket was removed. It has yellowed and darkened from staining.

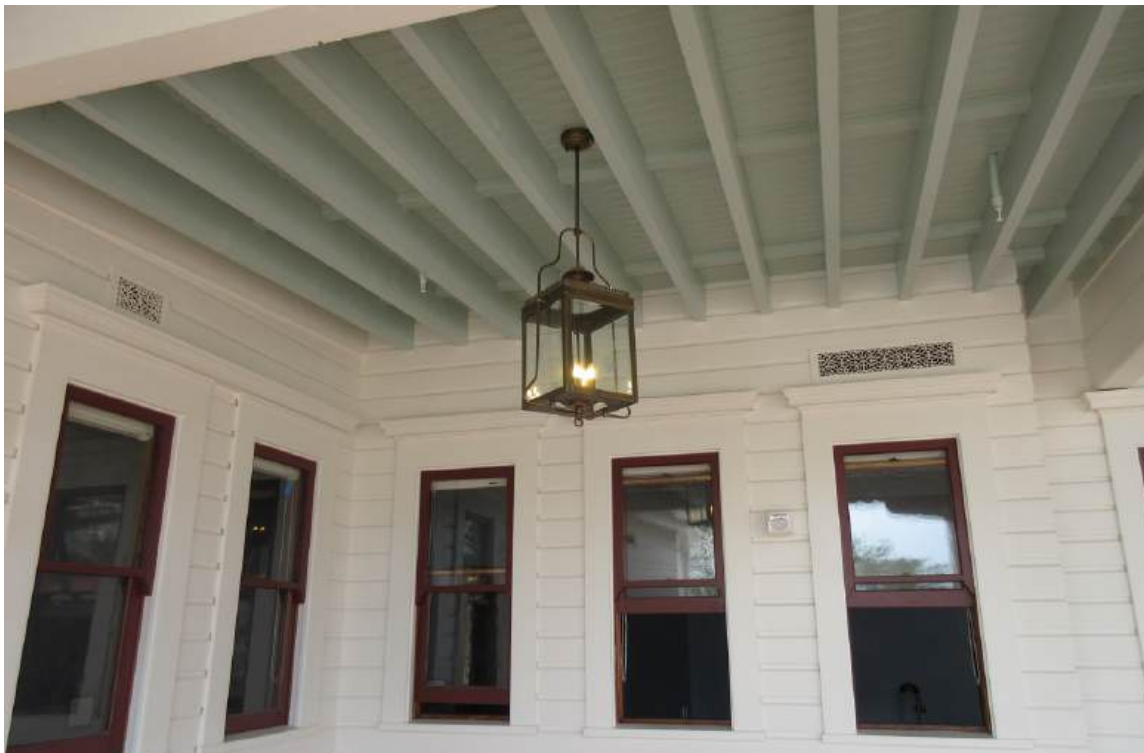
Figure 18: New Haint Blue at the Veranda ceiling adjacent to the “Del White” walls and dark red window sashes.

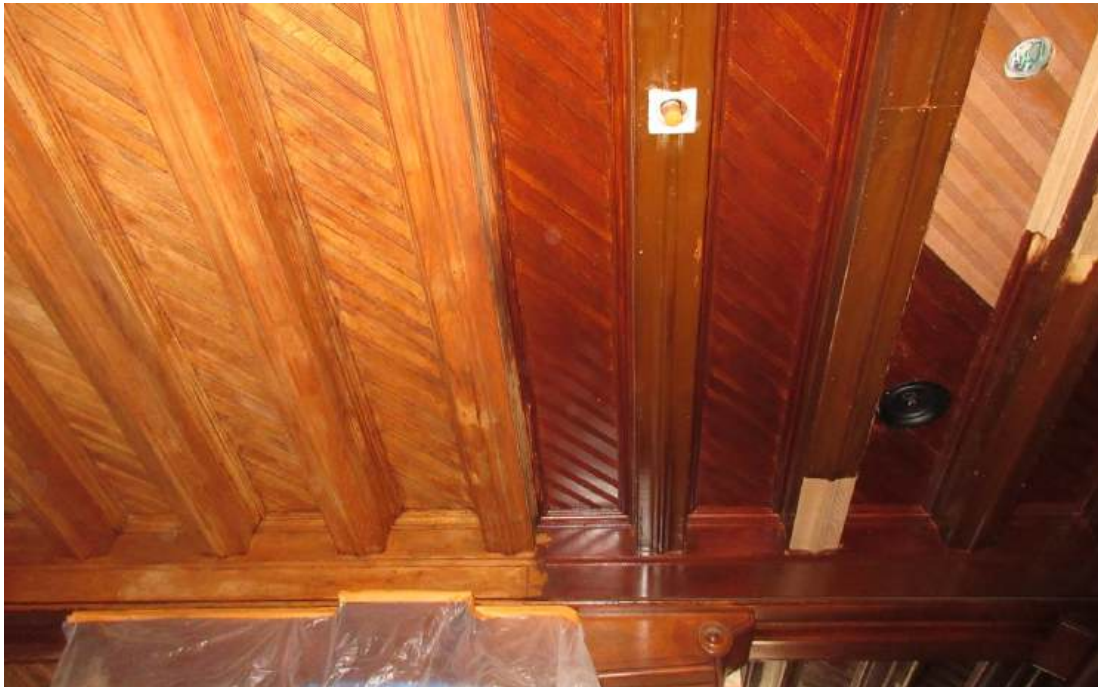
Figure 27: Much of the Lobby woodwork had been painted and/or re-stained (right). The ceiling on the left shows the white oak after being stripped, prior to the application of new stain and shellac. The lightest areas show where new oak was used to patch missing or damaged pieces.

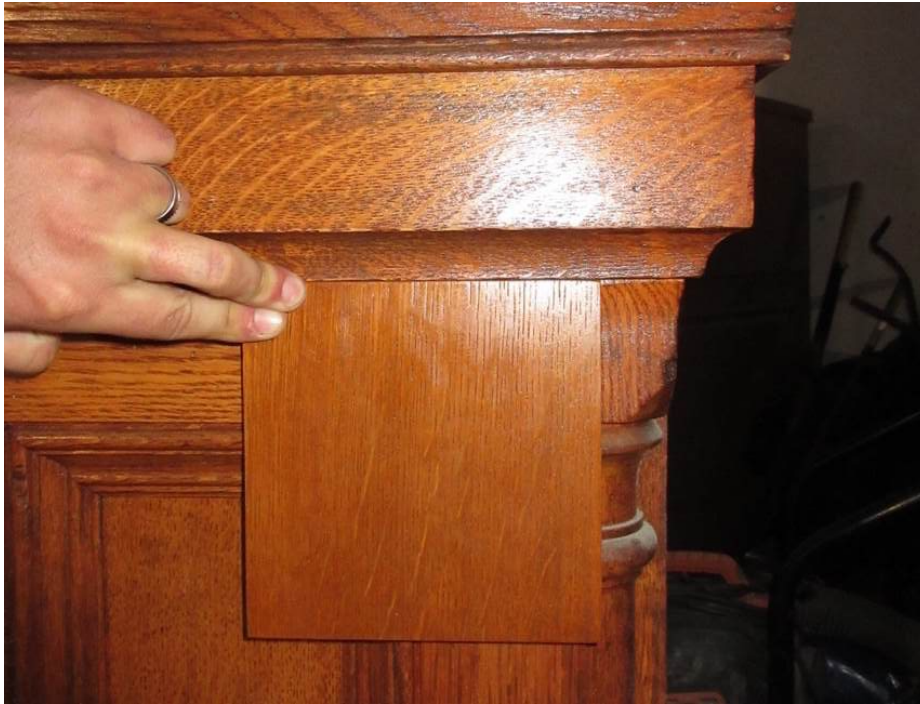
Figure 28: Matching the historic “golden oak” wood finish at an original Lobby column.

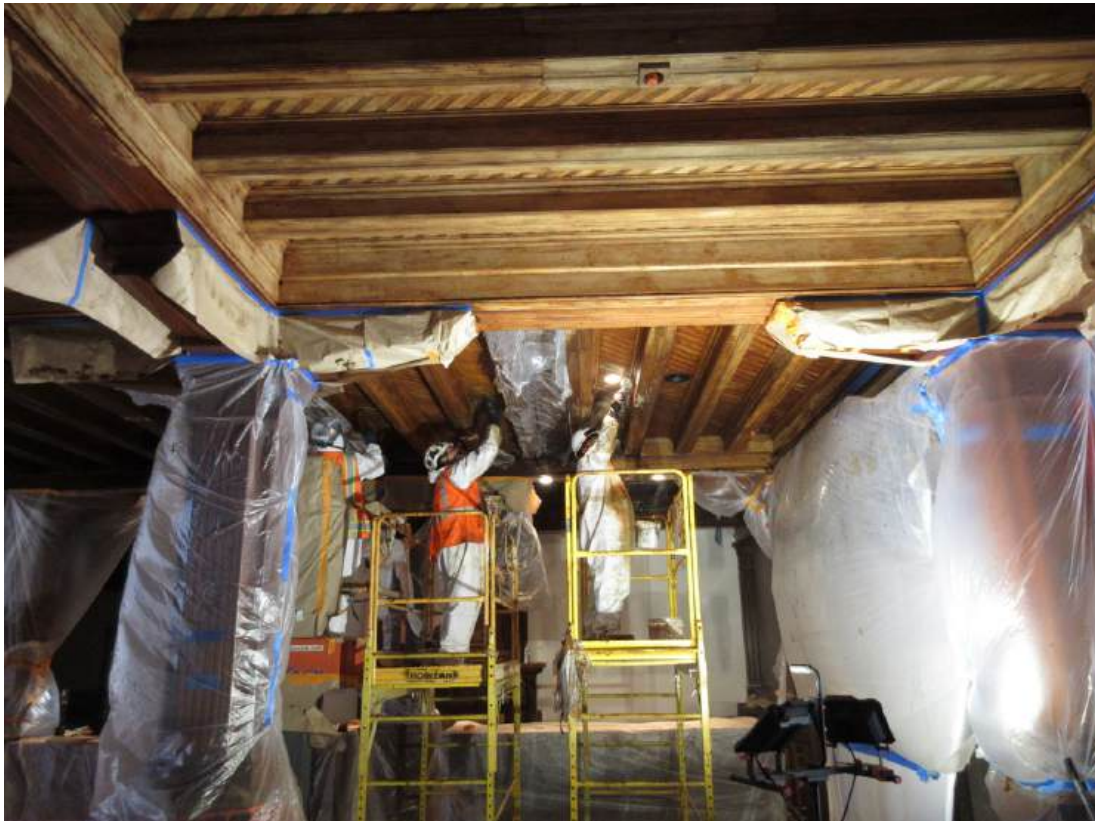
Figure 29: The unpleasant and tedious work of stripping original woodwork of its non-historic coatings prior to receiving new stain and shellac.

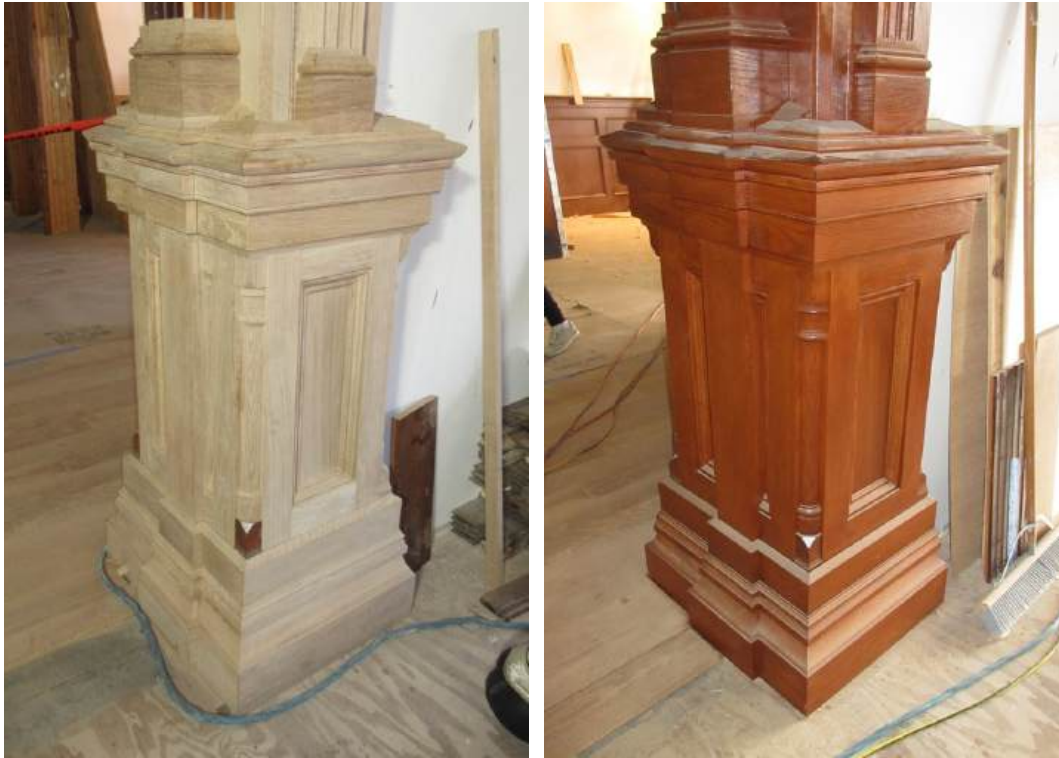
Figure 30: Before and after stain and shellac was applied to a replicated Lobby column.

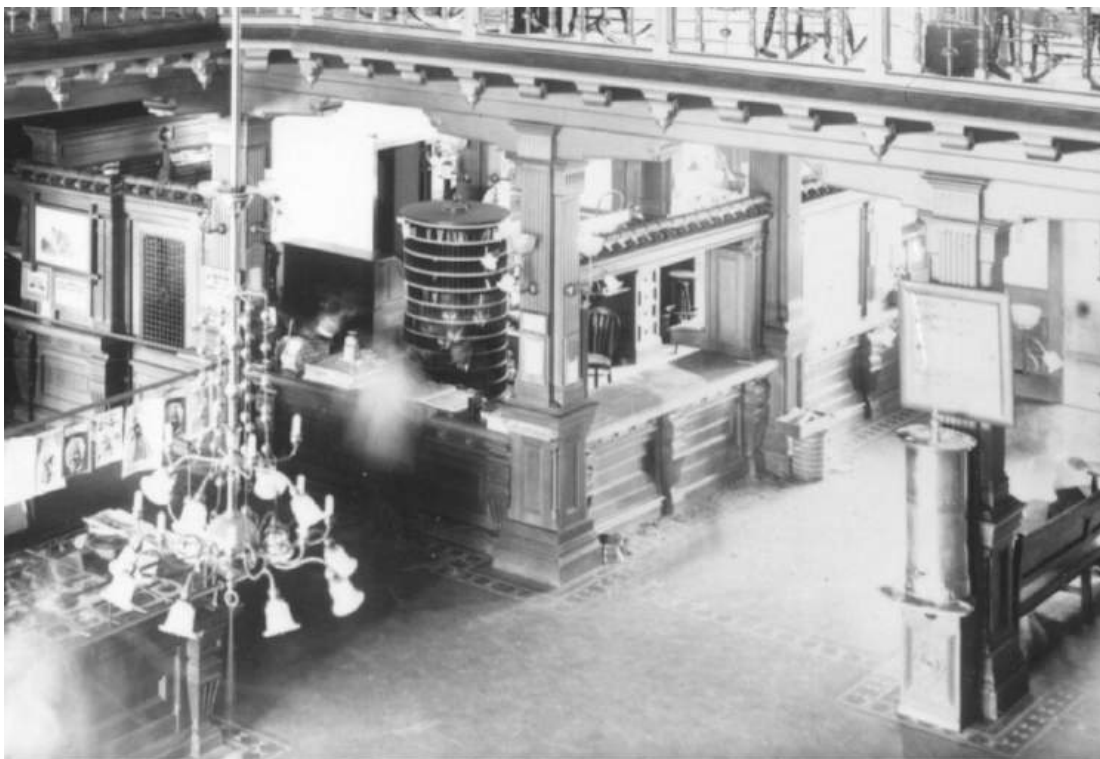
Figure 31: Historic photo of the Lobby, ca.1890. Note the smooth flooring and border pattern without visible joints. This appears to be linoleum. Image credit: Hotel del Coronado Archives.

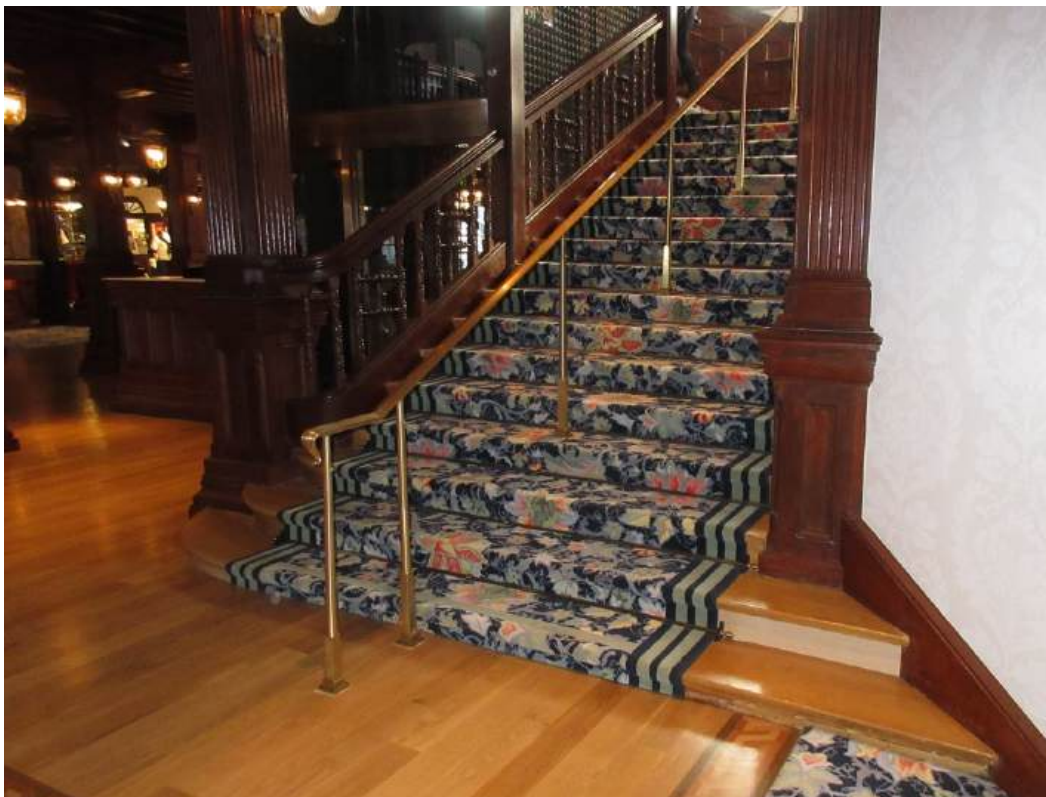
Figure 37: The main stairs in the Lobby after repair of the damaged treads. A new carpet runner and center bronze rail were installed.

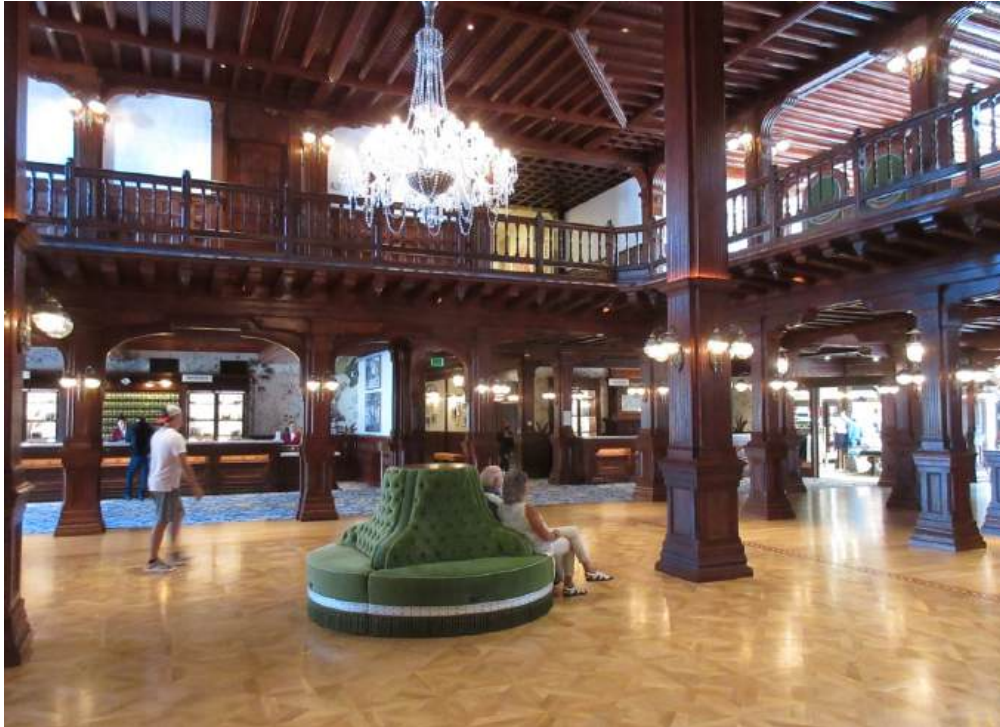
Figure 38: The restored and upgraded Lobby, looking northwest. The expanded Front Desk is on the left. The chandelier and sconces are new.

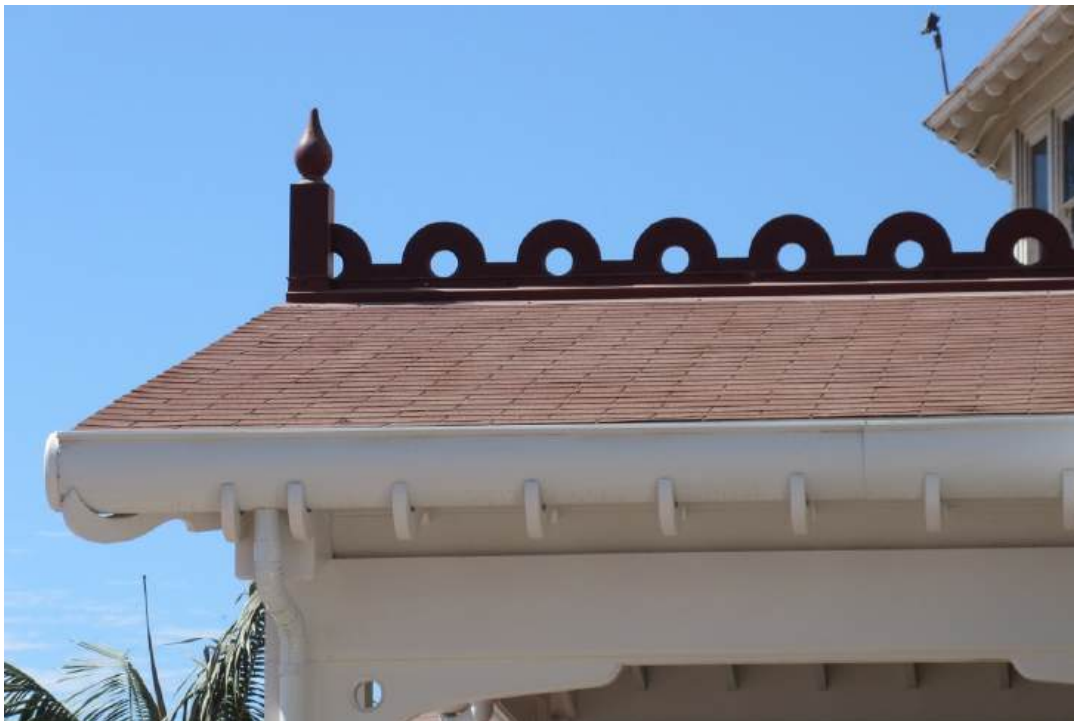
Figure 51: The missing ridge cresting at the gable roofs was recreated from historic photos using durable PVC with mahogany finials.

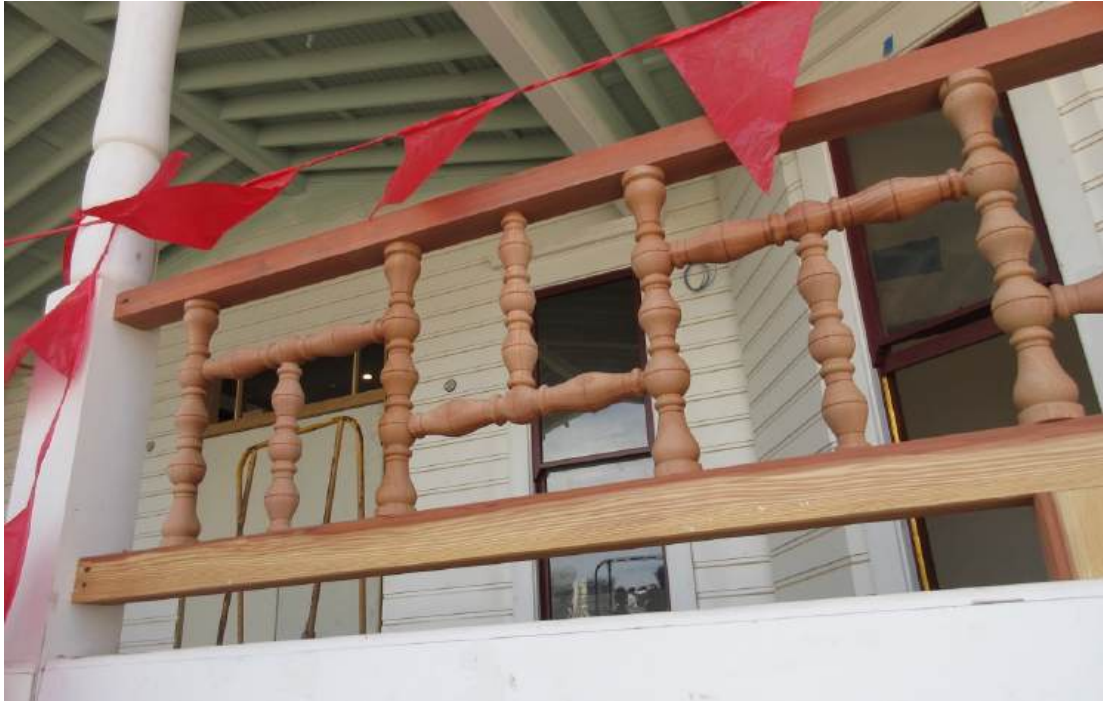
Figure 52: Newly fabricated mahogany guardrails at the Veranda that exactly match the historic detailing, prior to being painted.

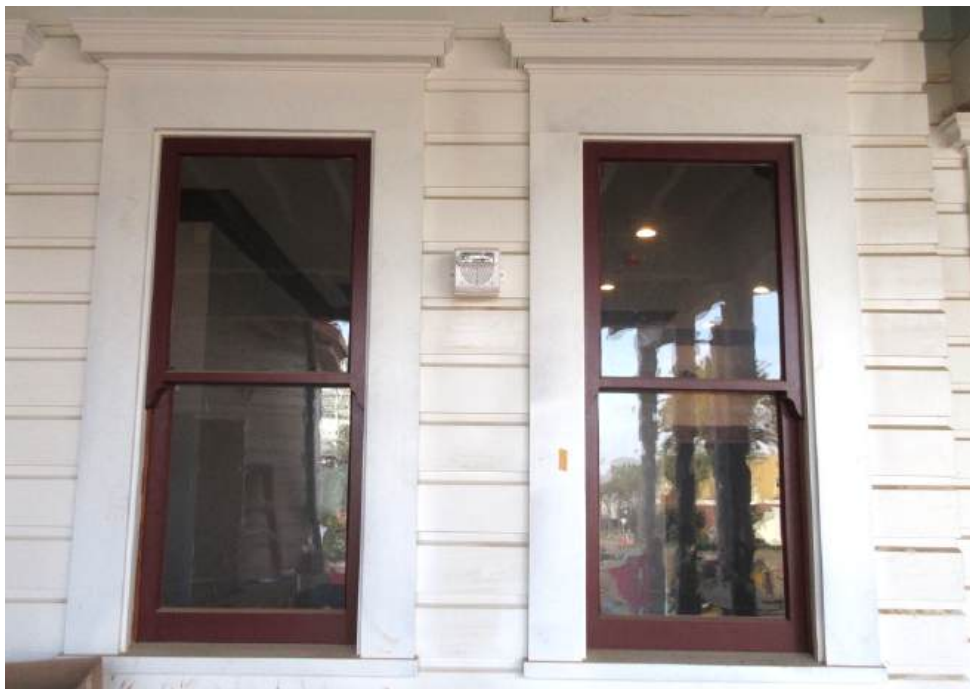
Figure 57: Replica double-hung windows and trim at the Veranda. The “ogee lugs” are the curving extensions of the sash frame that are on all of The Del’s original window sashes, upper and lower.

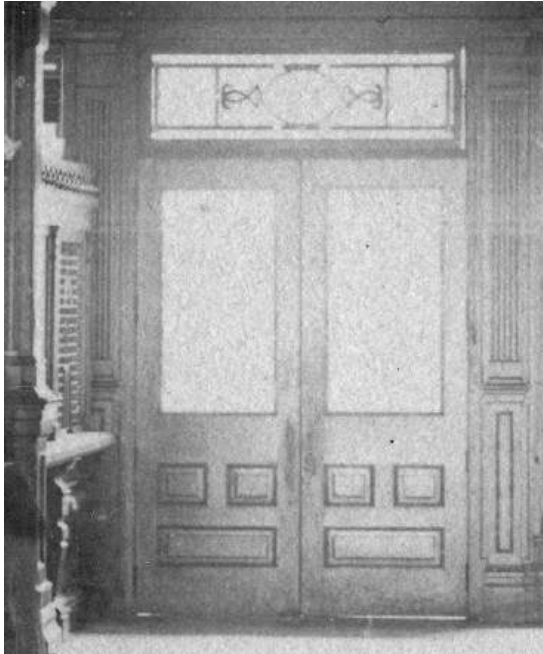
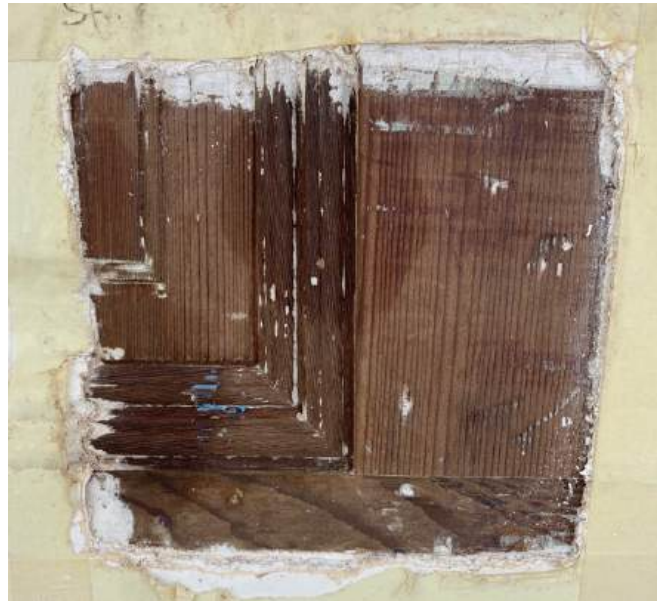
Figure 58: Historic photo of an original exterior door pair at the Lobby (left). Also note the original stained-glass transom. A historic panel door (right) was stripped down to reveal the molding profiles to match.

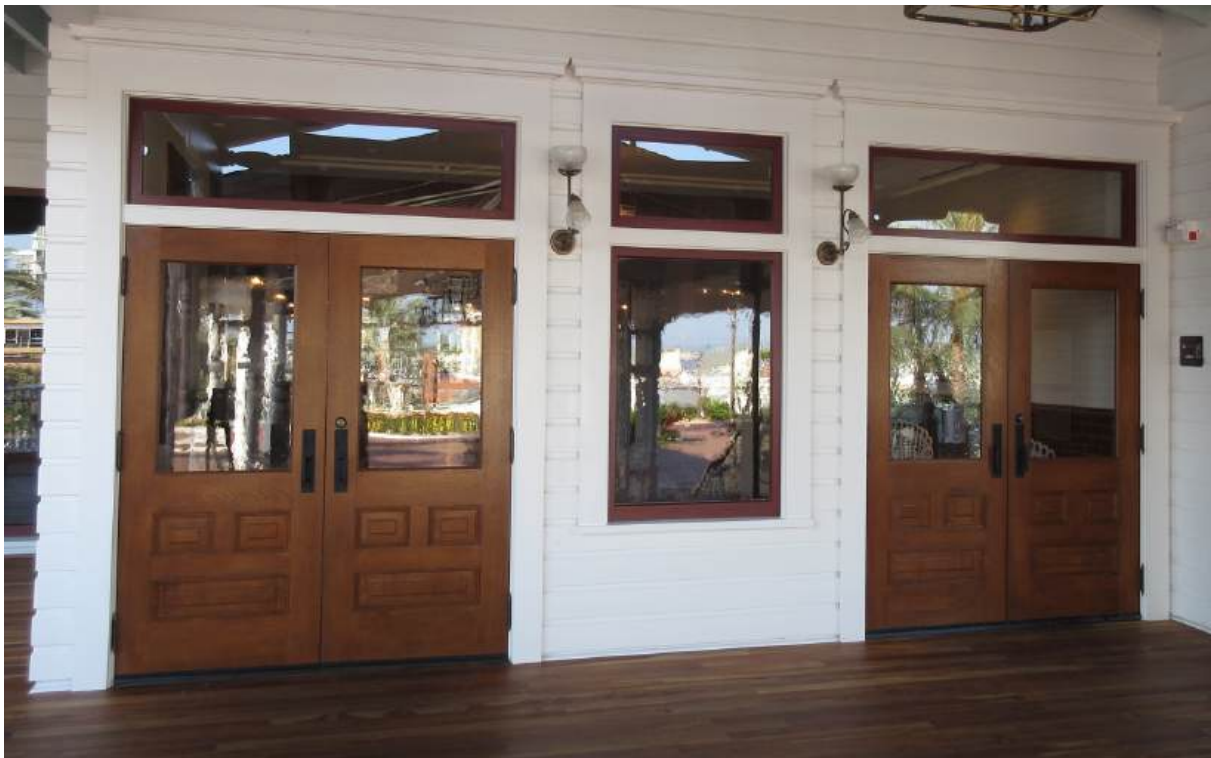
Figure 59: Replica white oak panel doors at the main entrance with a stain and shellacked finish and Victorian reproduction bronze hardware. The doors were widened to 36-inches to comply with the ADA. The stained-glass transoms are not yet installed.

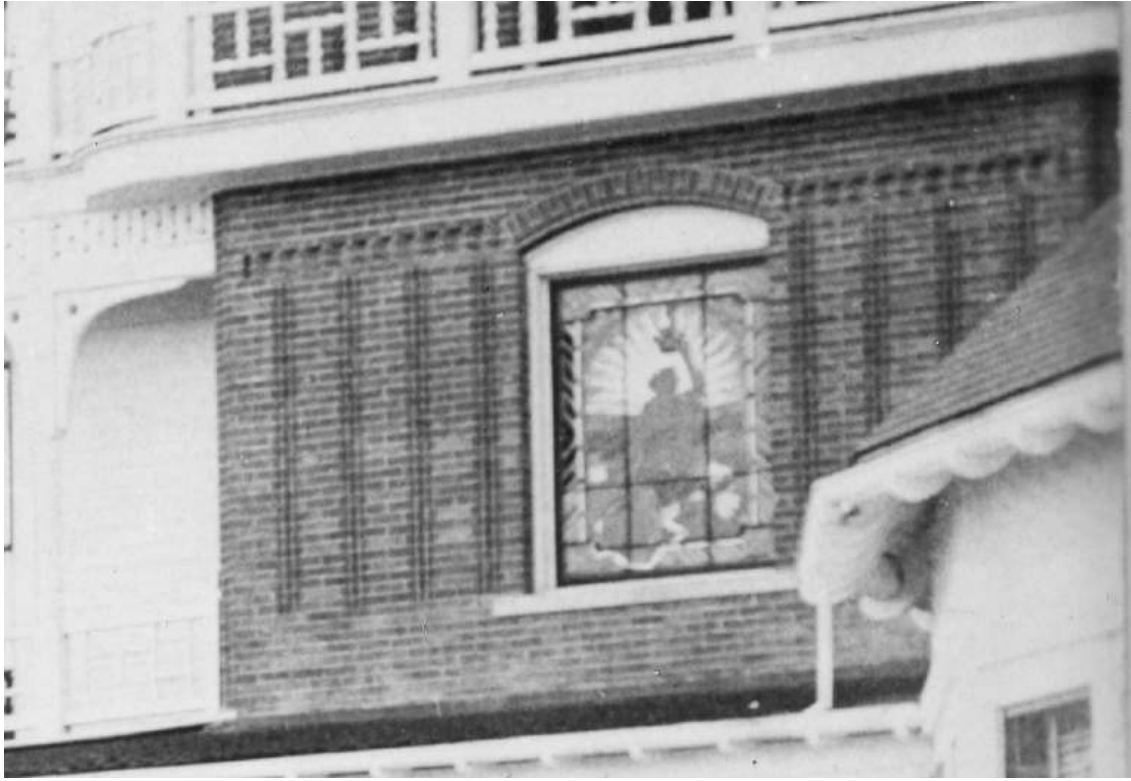
Figure 60: Historic photo of the grand chimney, ca.1890. This shows the brick detailing that was recreated at the lower two floors. Image credit: Hotel del Coronado Archives.

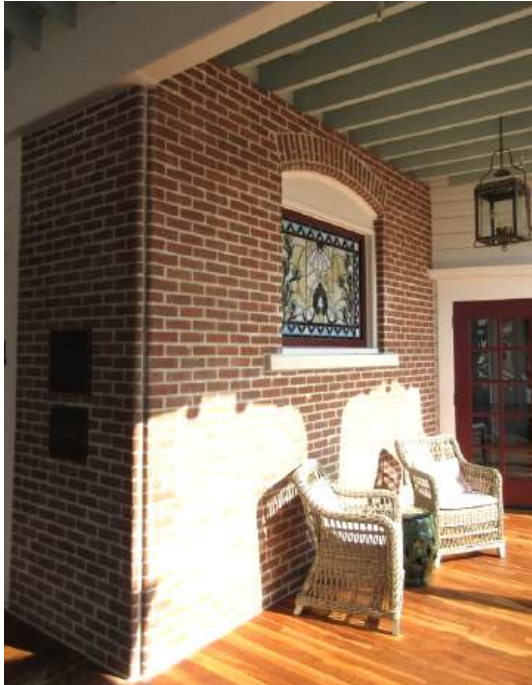
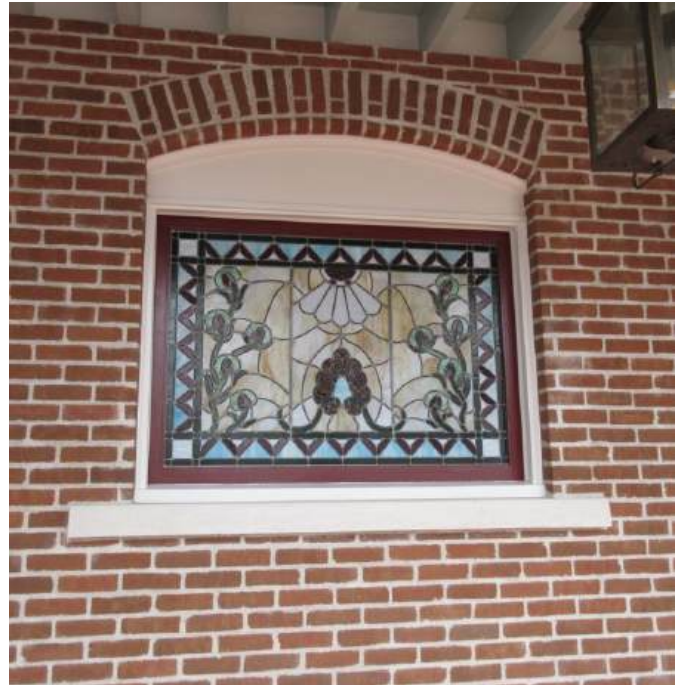
Figure 63: Replicated first floor brickwork framing a new stained-glass window based on historic photos. The sill is precast concrete.

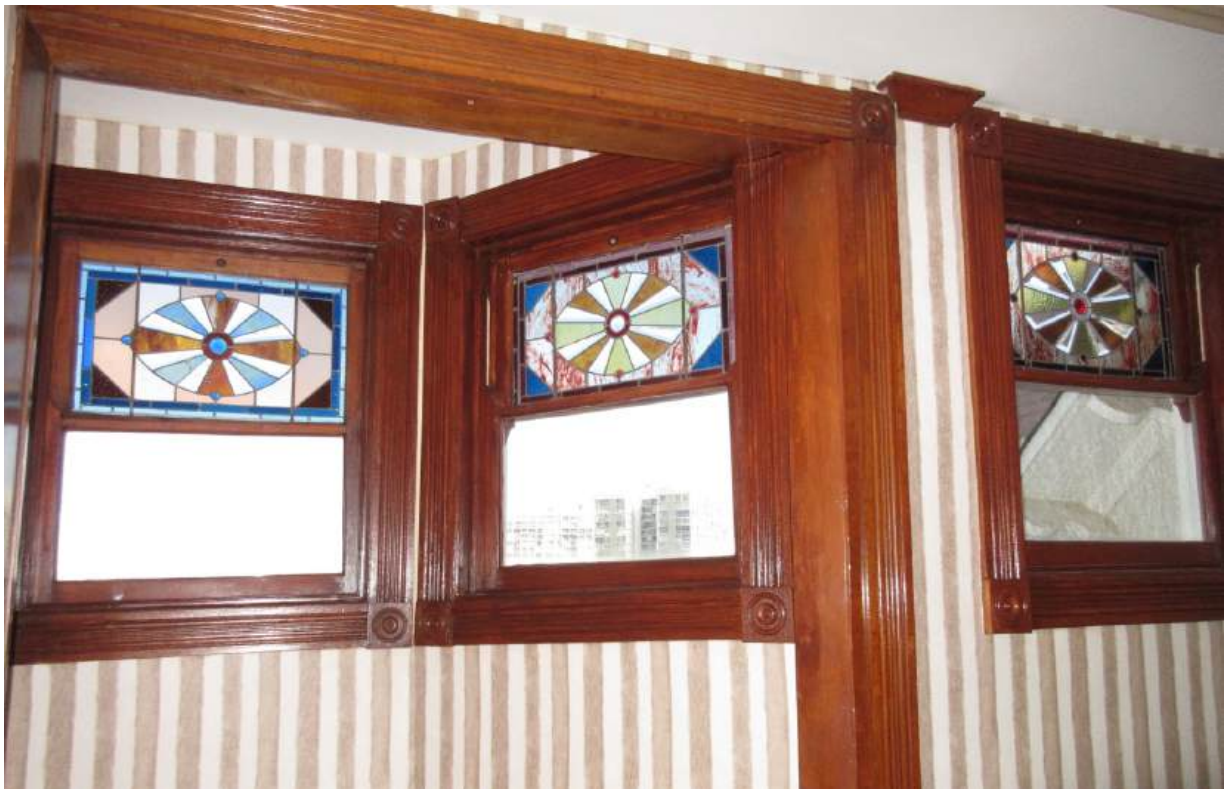
Figure 64: Three historic stained-glass windows at the third floor west stairwell were restored and reinstalled. Two missing adjacent windows with the same design are being fabricated.

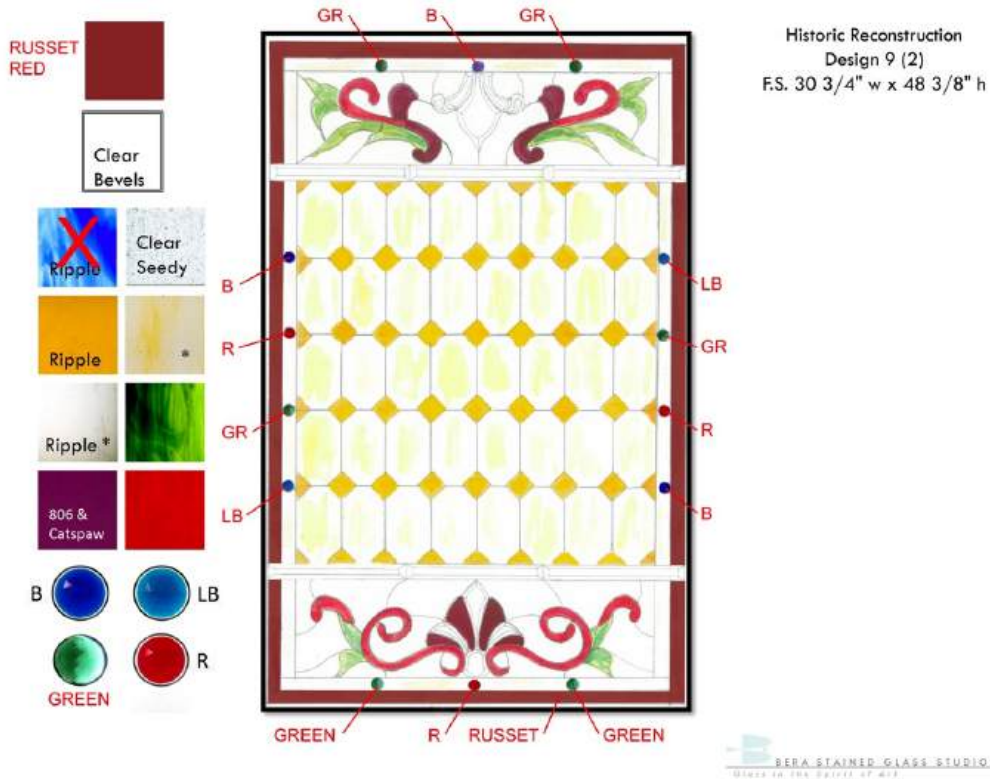
Figure 65: Drawing of a stained-glass window (Design 9) from Bera Stained Glass Studio which was used to finalize the design and glass color palette. This window will be located adjacent to the VIP Check-in area.

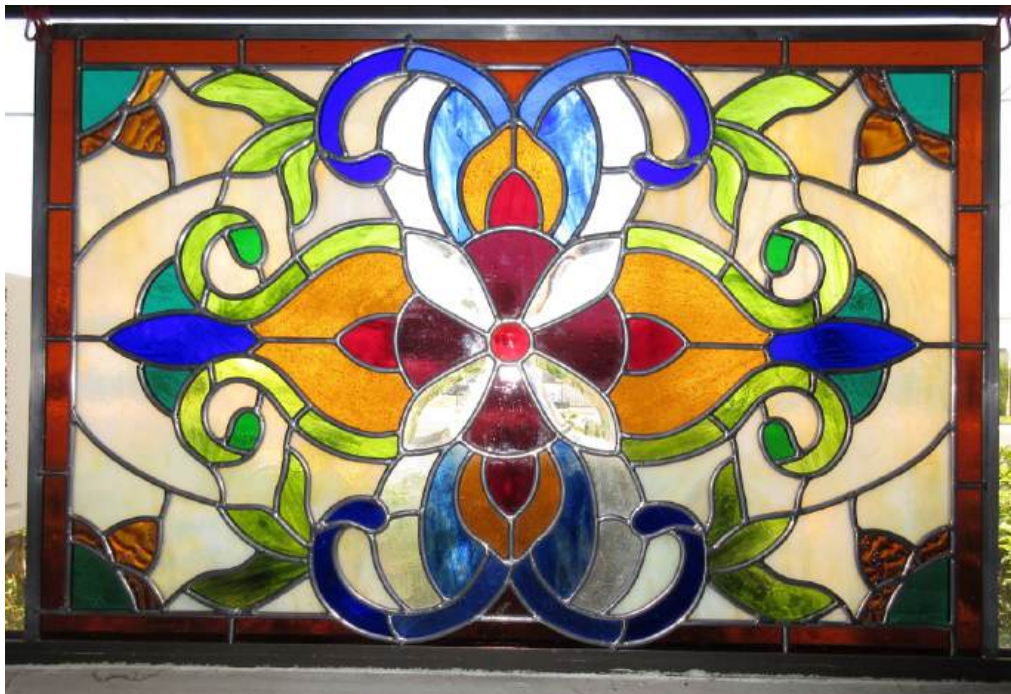
Figure 66: This replica window is one of three that will be installed in the second floor west stairwell.

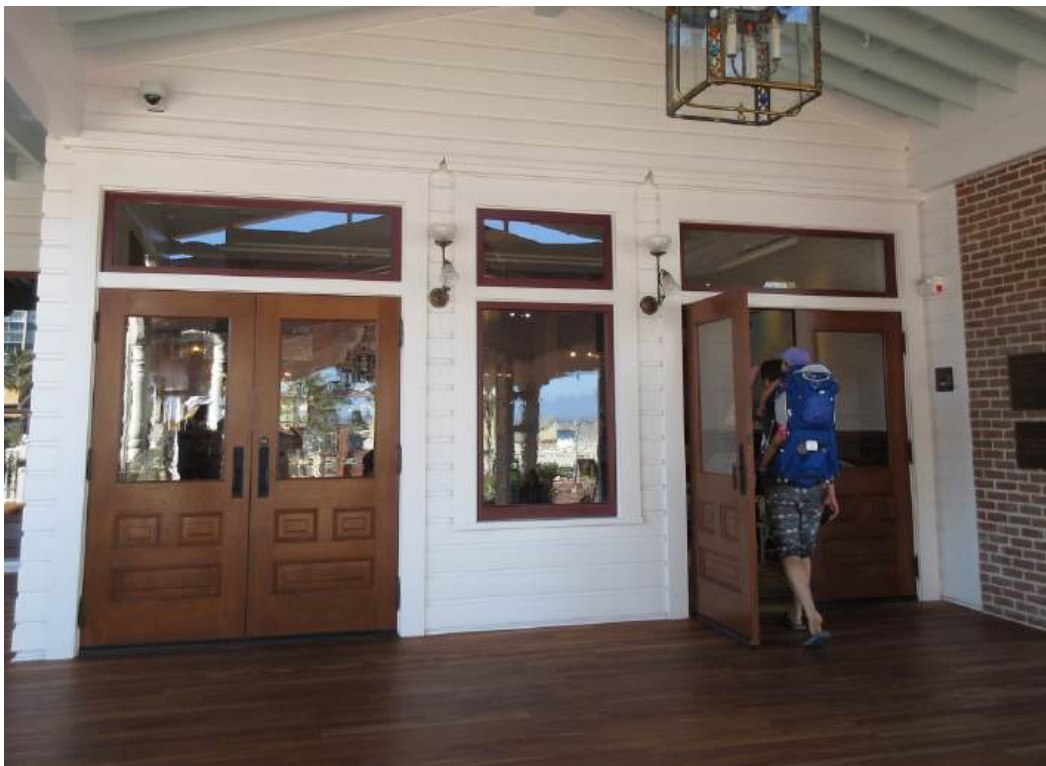
Figure 90: After - Same view after restoration with two historic door pairs recreated, 9-19-21. The three stained-glass transoms still need to be installed.
