# Hotel del Coronado Front Entry and Porch Restoration Final Report to the City of Coronado

By P. David Marshall, AIA, Preservation Architect  
September 27, 2021

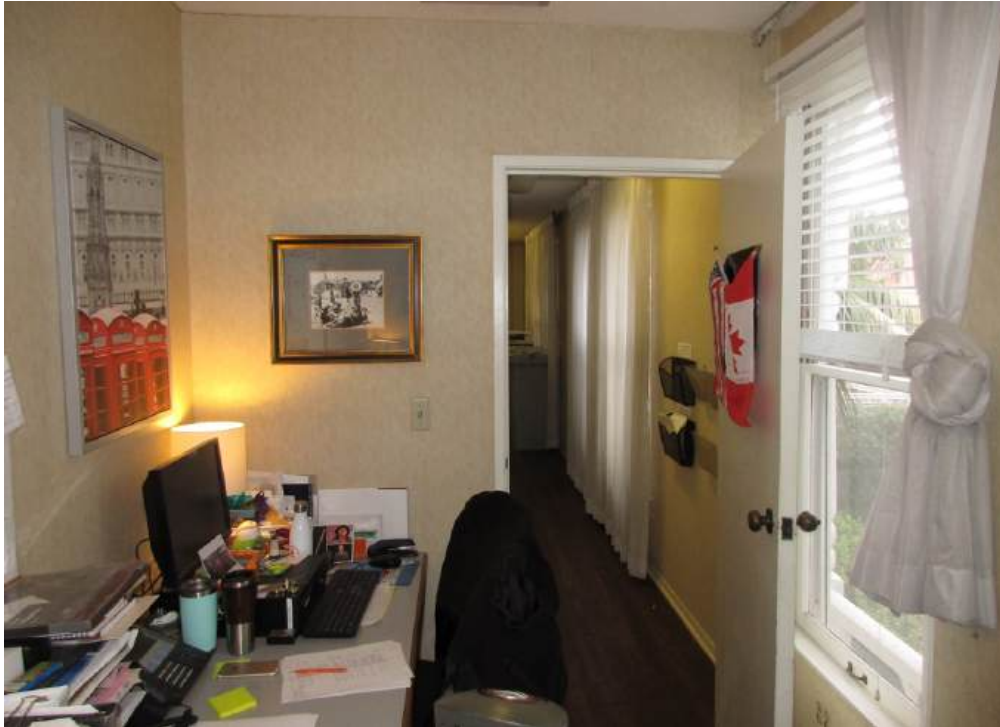
Figure 91: Before – The offices and corridor at the south end of the first floor that were added after 1960, looking east, 2-28-18.
